Geophysical methods of investigating Seismic refraction at dam sites in Nigeria

Seismic refraction study has been carried out on Gurara Dam Phase II proposed axis with the aim of determining its feasibility for the founding of a dam. The field techniques involved off-end/reverse and split spread shootings on five profiles. The study site is situated on the Precambrian Crystalline Basement Complex rocks of North Central Nigeria. Velocity values obtained from the shots vary between 183 ms^{-1} in unconsolidated soil materials and 6522 ms^{-1} in the fresh bedrock. The overburden is presumably characterized by low to moderately high velocity varying between 183 and 1235 ms^{-1} . Fractured/partially weathered basement rocks within the study area are presumably defined by velocity ranging from 543 to 1667 ms^{-1} . The fresh bedrock is presumably characterized by velocity in excess of 2000 ms^{-1} . The results of the seismic refraction study conducted on the proposed dam axis showed that some portions of the western flank of the axis present noticeable seepage characteristics within the bedrock especially on profiles 1 and 2. Profile 4 on the eastern bank of Gurara River present a do

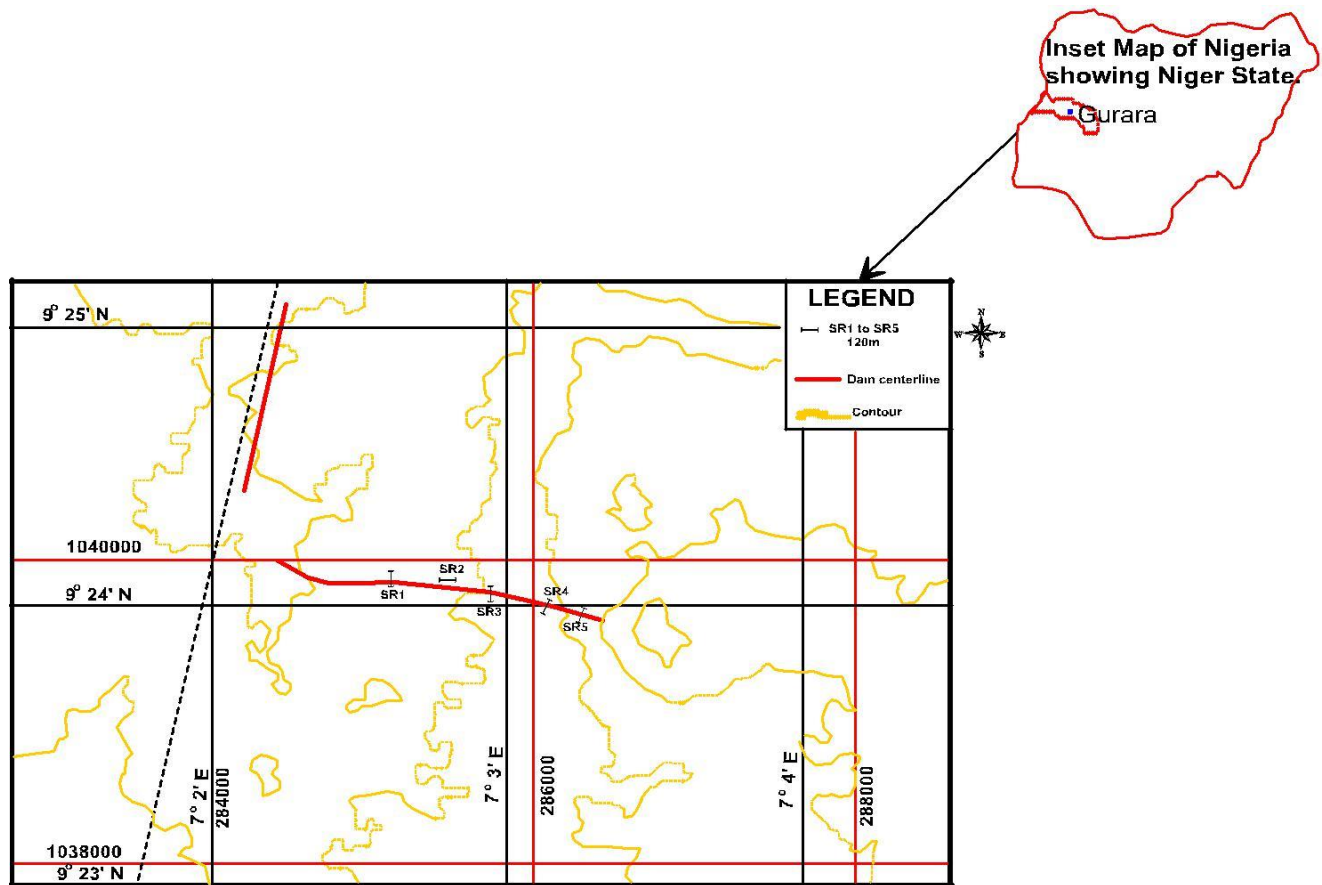
Figure 1. Base map of Gurara Dam Phase II area showing the proposed dam axis and the seismic refraction profiles.

The Gurara Phase II Dam Project site (Figure 1) is situated about 62 km northwest of Abuja (administrative capital city of Nigeria) and 58 km southeast of Minna (Niger State capital city) metropolitan area. The main dam axis is oriented in West - East direction. The proposed upstream area of the dam is situated around Sana, Buru, Kumida and Shakwoi villages while the downstream is situated around Tuchi village. In the diagram of Figure 1, SR1 to SR5 corresponds to the profiles 1 to 5 while the red line indicates the proposed dam axis.

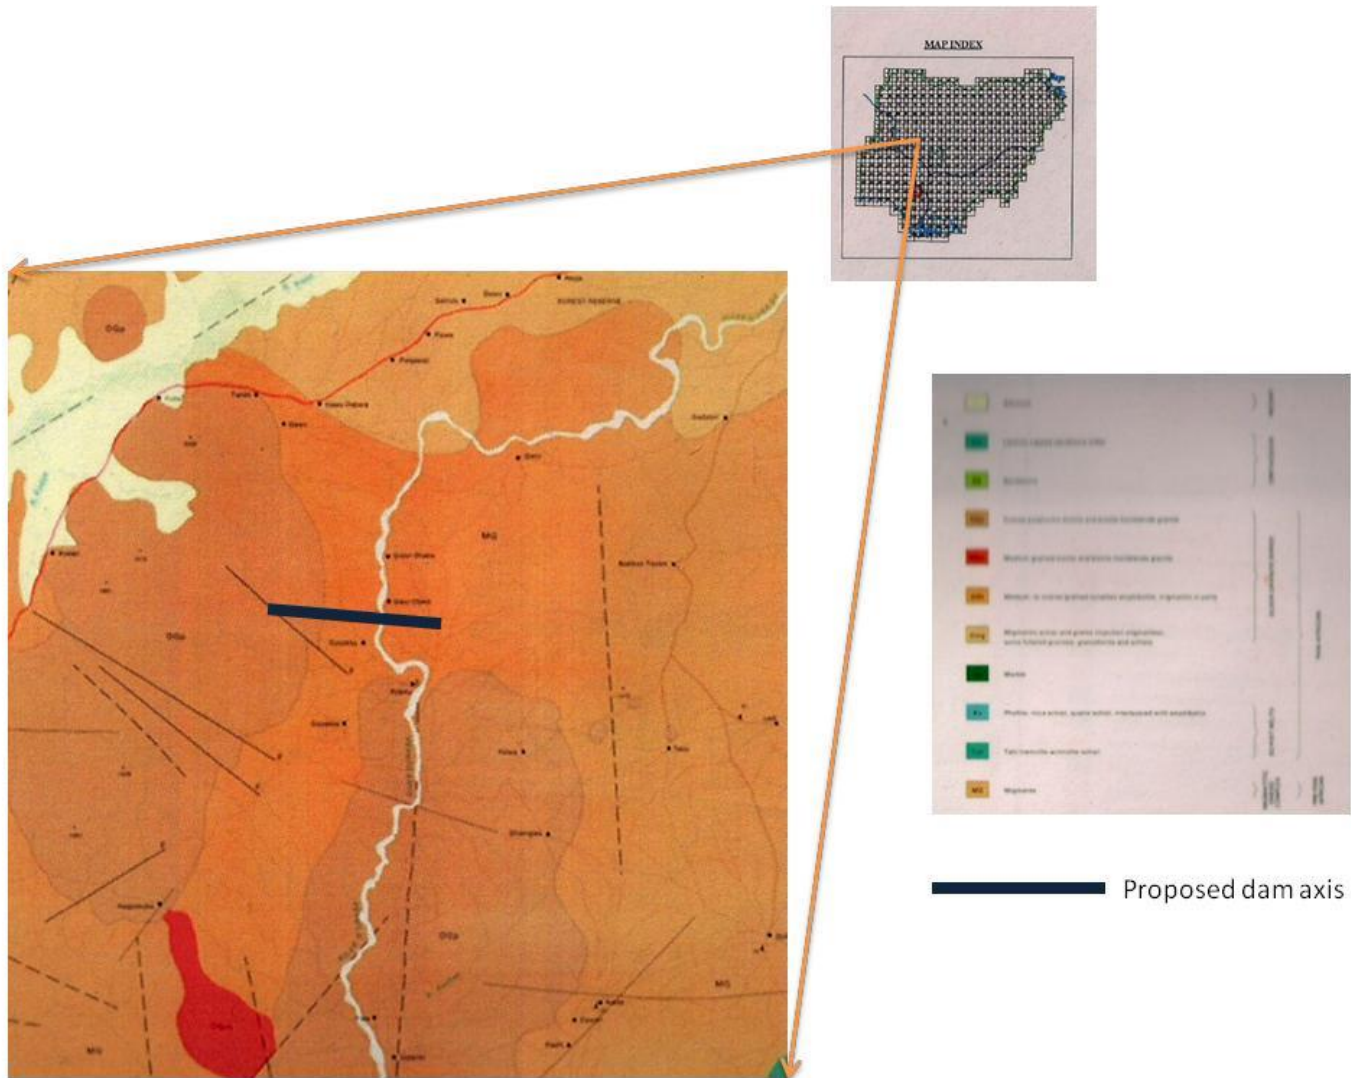
Figure 2. Geological map of Gurara Phase II Dam axis area (GSN, 2003 sheet 185).

The site of investigation is underlain by the Precambrian Basement Complex rocks of North Central Nigeria (Figure 2). The major lithological units are schist,

migmatite gneiss, porphyroblastic gneiss and granite gneiss while minor units are the amphibolites, pegmatites and quartz veins. Evidences of tectonic activities, in form of multiple intrusive quartz veins cross-cutting micro faults and jointing abound in the study area. Linear structures especially joints were observed to predominate the structural patterns while localized faulting and folding were observed especially within the granite gneiss and migmatites. On the proposed upstream area of the study area, the migmatite gneiss occurs mostly on the eastern flank of river Gurara while the granite gneiss covers a wider portion of the area. The migmatite gneiss rocks do not show a definite contact with the granite gneiss but may have been intruded by the latter. The migmatite gneiss appears darker probably having a contact with the porphyroblastic gneisses between Burum and Kumida areas. The migmatite gneiss rocks are less resistant hence the large scale weathering observed when

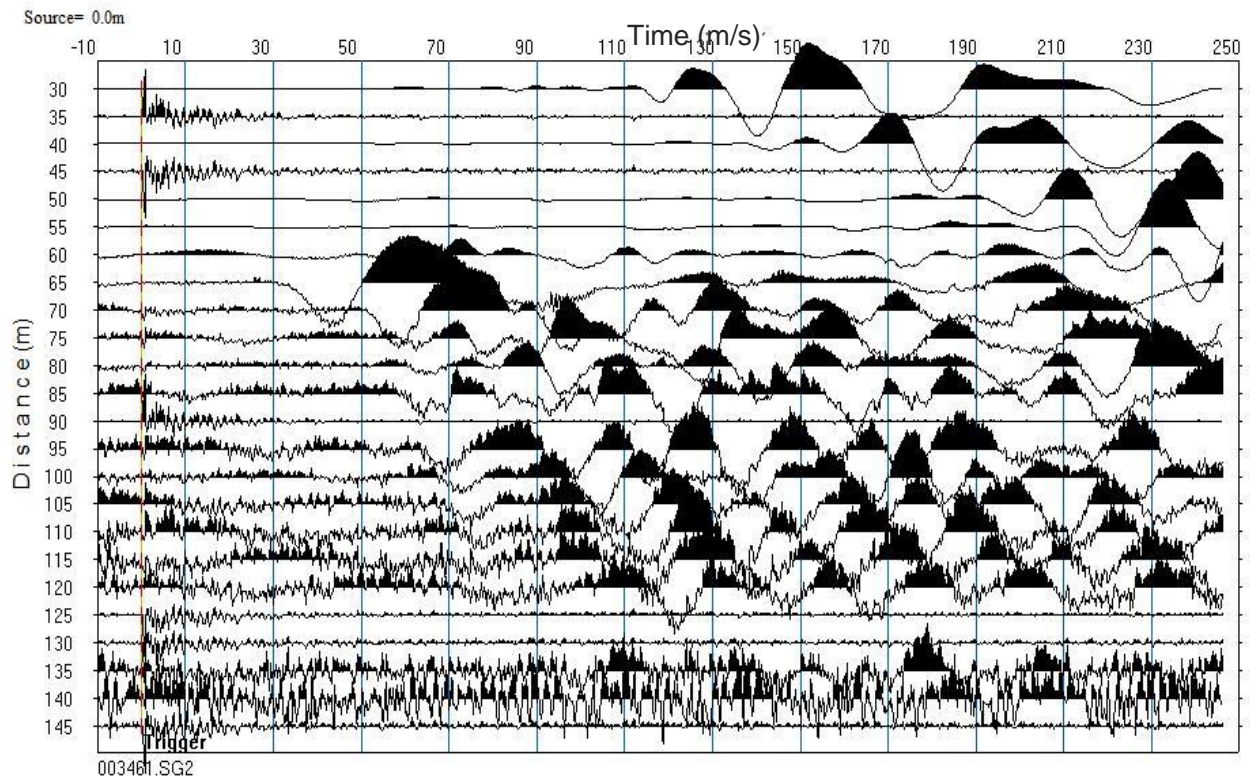
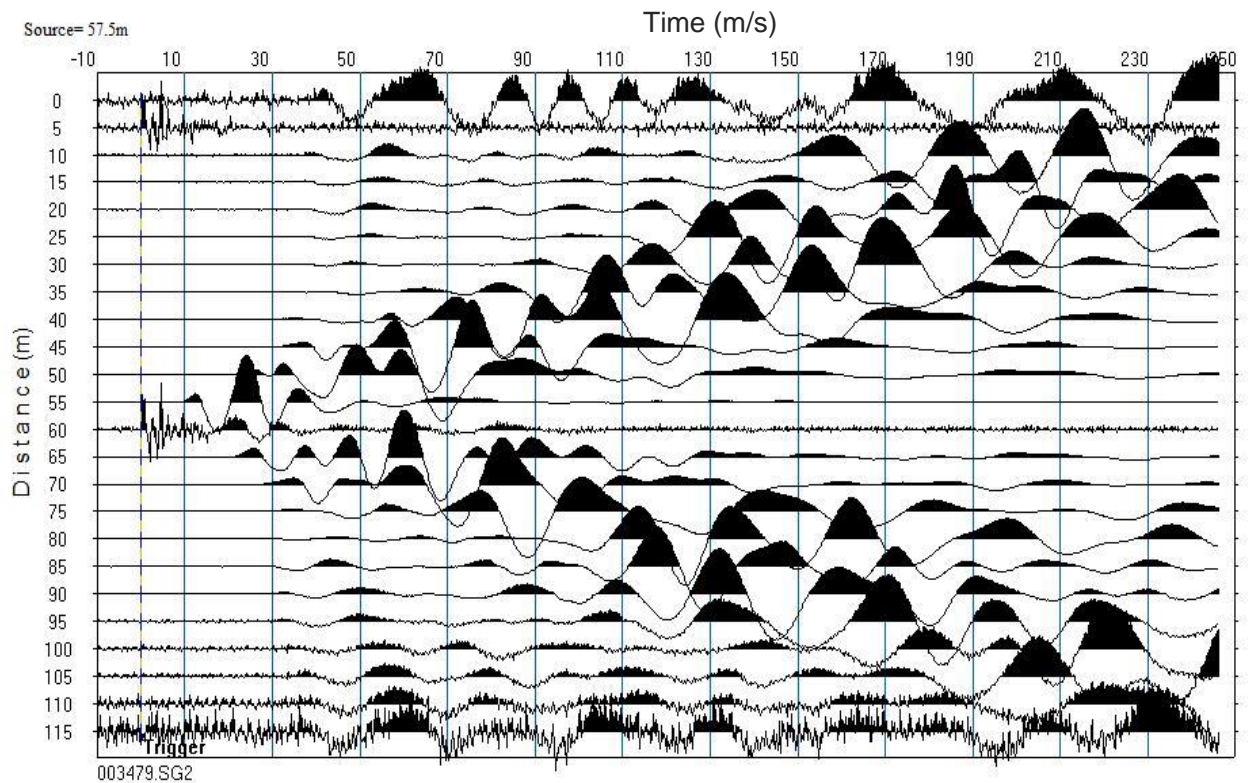
Figure 3. Typical field monitor records.

The seismograms showed that the records of shots taken at the extremities and within the profiles present moderately discernible records while those taken at 30 m offset present barely discernible records. Velocity values obtained from the shots vary from 183 m/s in the unconsolidated soil materials to 6522 m/s in the fresh bedrock. Using Palmer (2001) classification of seismic velocity values of friable soil to approximate about 400 m/s, weathered material to approximate 700 m/s, and a main refractor with an irregular interface to approximate seismic velocities between approximately 2000 and 5000 m/s, the overburden in Gurara Phase II site is therefore presumably defined by low to moderately high velocity values varying between 183 and 1235 m/s. Fractured/partially weathered basement rocks within the study is defined by velocity values ranging from 543 to 1667 m/s. Thicker low velocity layers (ranging from 8.45 to 12.24 m) were delineated on profiles 1 and 2. The near-surface higher velocity values mostly in excess of 2000 m/s (Tshering, 2006) obtained within the vicinity of the river (profiles 3 and 4) indicate the possibility of shallow fresh basement rocks. Geo-velocity section generated for profile 1 is presented in Figure 9. The profile which is located on the extreme west of the dam axis is characterized by low velocity values varying between 263 and 571 m/s which are diagnostic of overburden materials with thickness values varying between 8.45 and 18.68 m.

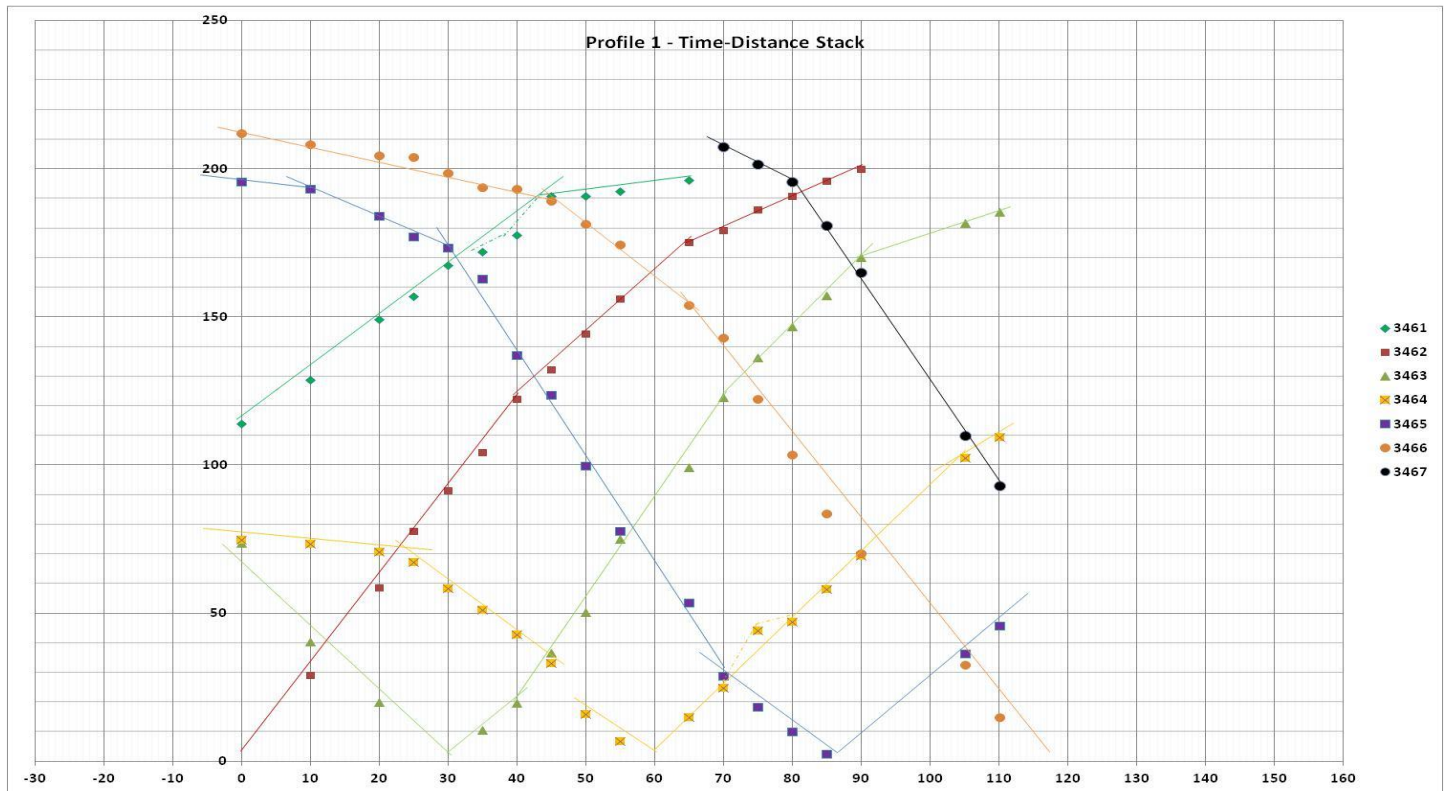
Figure 4. Composite travel time-distance plot of profile 1.

The time-distance plots for the shots on entire profile length are used to generate composite travel time-distance plots (Figures 4 to 8). A combination of the interpreted time-distance plots are utilized for generating seismic refraction (geo-velocity) sections.

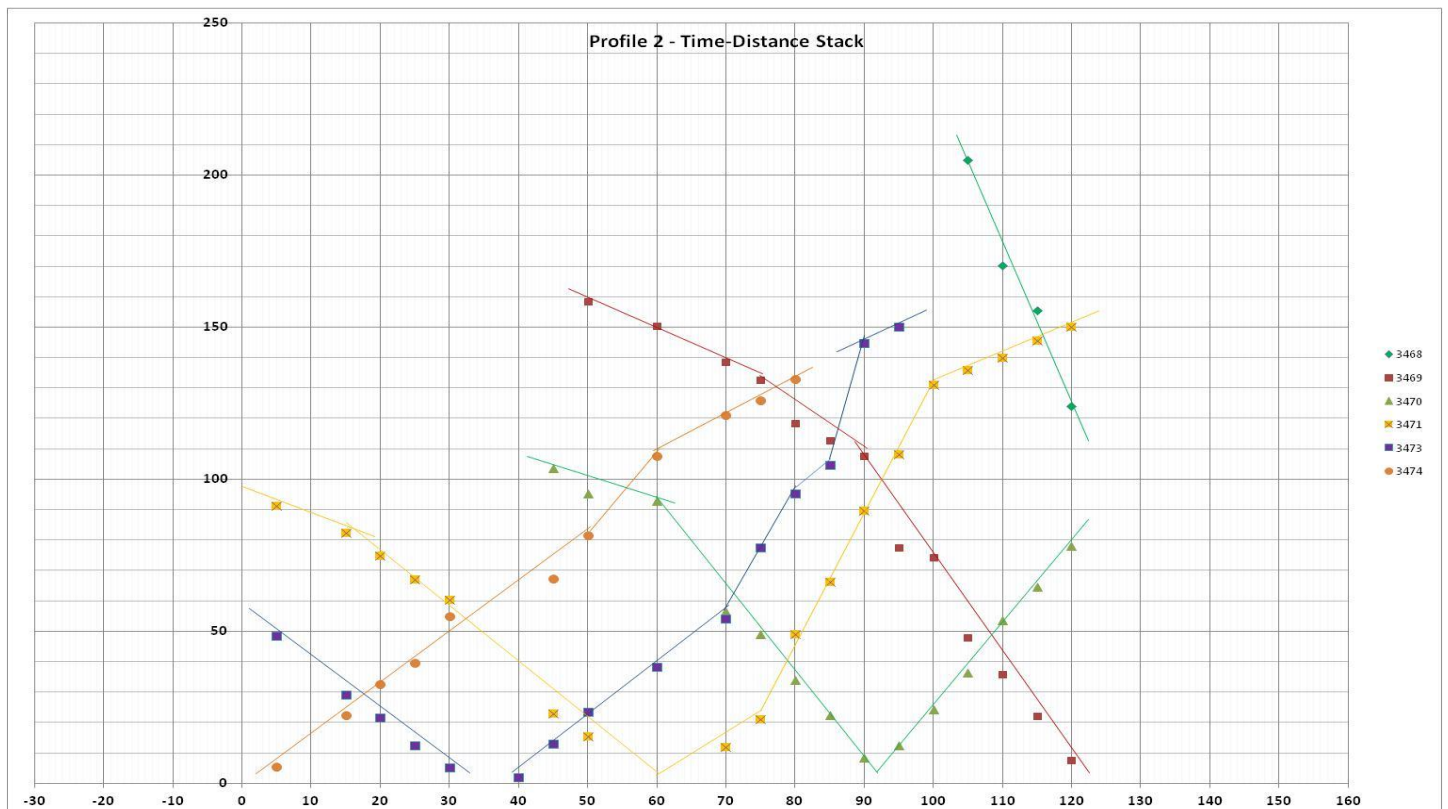
Figure 5. Composite travel time-distance plot of profile 2.

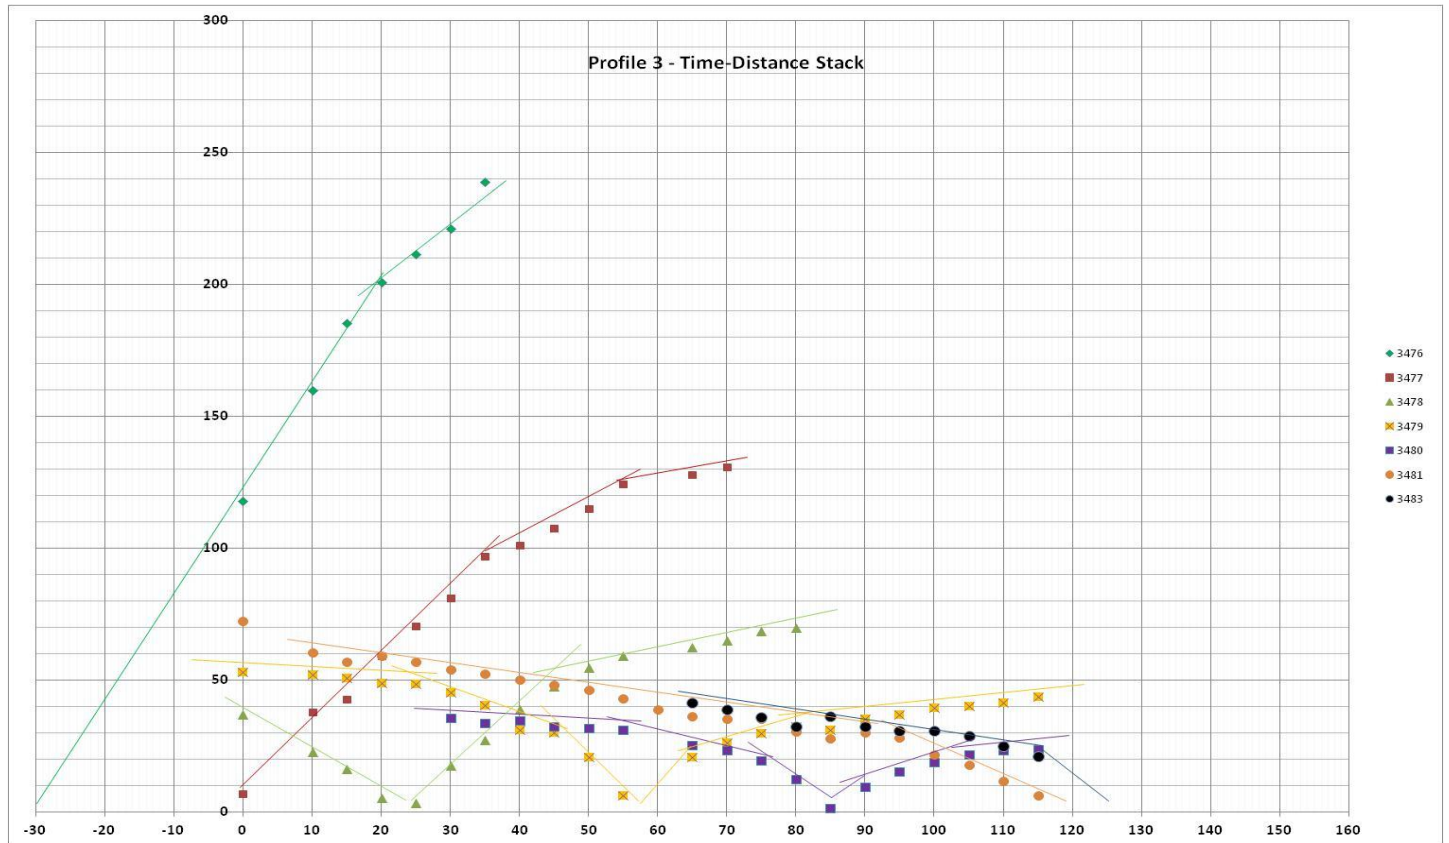
Figure 6. Composite travel time-distance plot of profile 3.

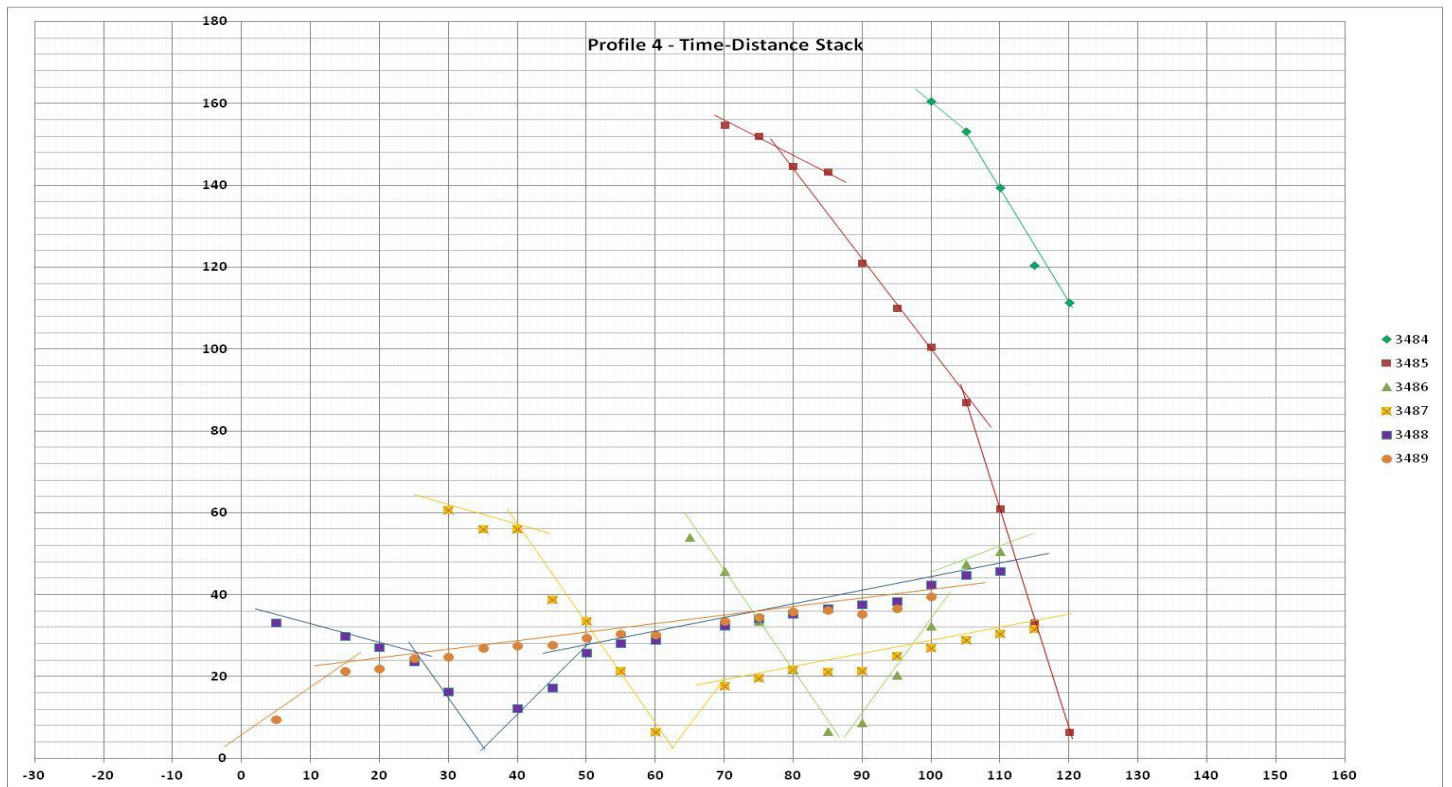
Figure 7. Composite travel time-distance plot of profile 4.

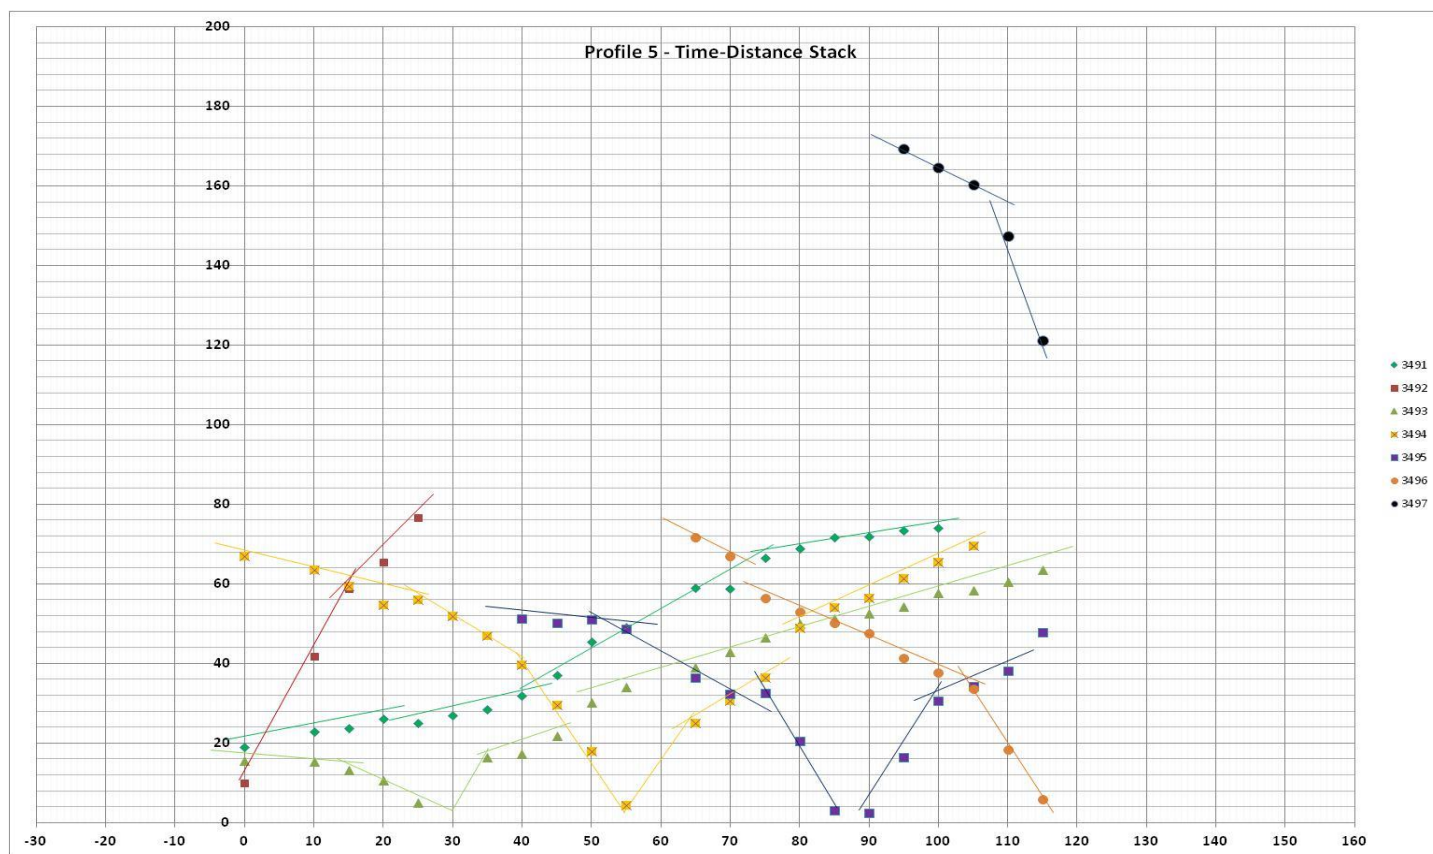
Figure 8. Composite travel time-distance plot of profile 5.

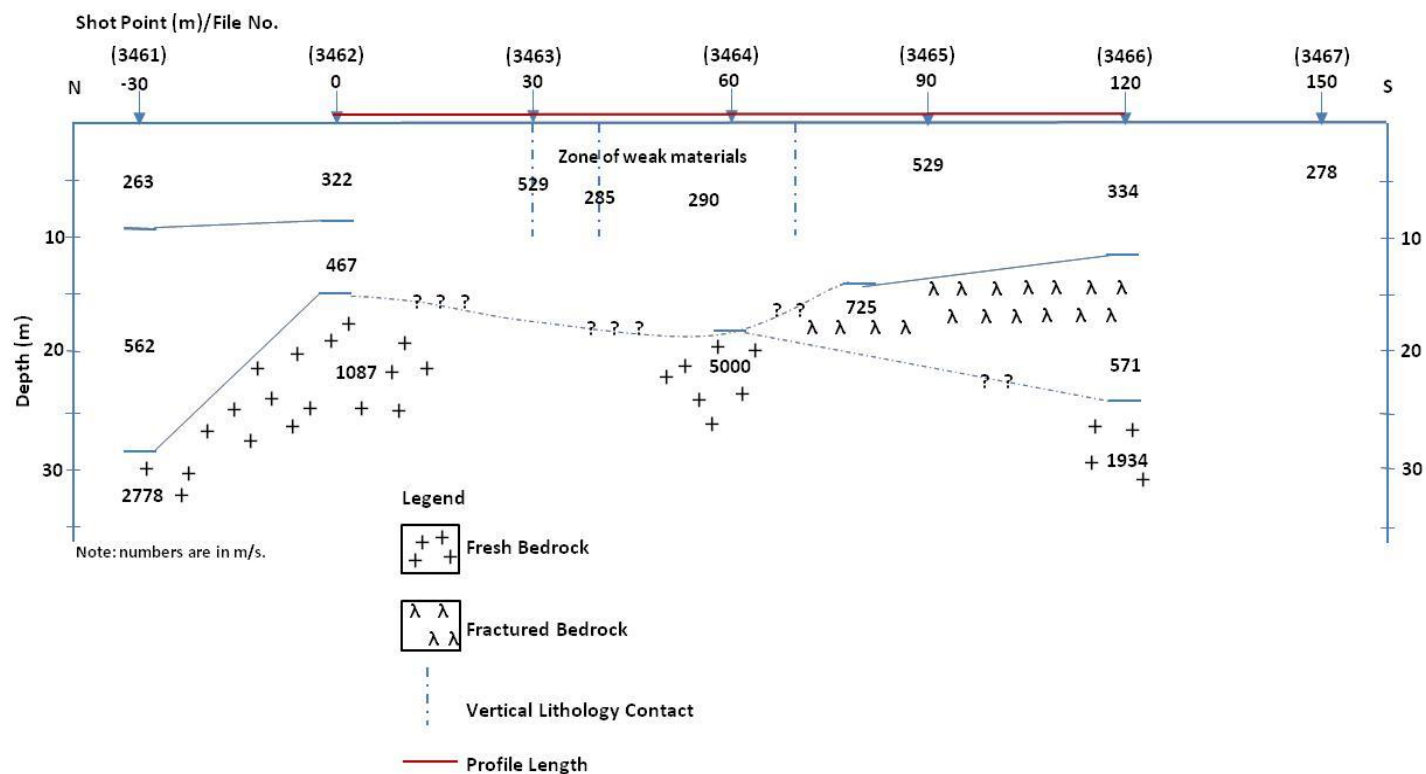
Figure 9. Seismic refraction (geo-velocity) section of profile 1.

Adopting Kilty et al. (1986) deduction that velocities in the bedrock range from 1,829 to 7,620 m/s, the bedrock in this study is consequently presumably characterized by higher velocity values ranging from 1087 to 5000 m/s. A column of low velocity materials (285 to 290 m/s) were delineated between Station 30 and 70 m perhaps indicative of weak materials. Existence of fractured basement (defined by 571 to 725 m/s) is suspected at the southern flank of the profile. Geo-velocity section generated for profile 2 is presented in Figure 10. Profile 2 is the only profile located parallel to the proposed dam axis. The overburden materials are characterized by low velocity values varying between 185 and 597 m/s with thickness values ranging from 8.11 to 13.74 m. The bedrock is characterized by fairly high velocity values varying between 1000 and 1613 m/s. Low velocity materials (243 to 383 m/s) were delineated between

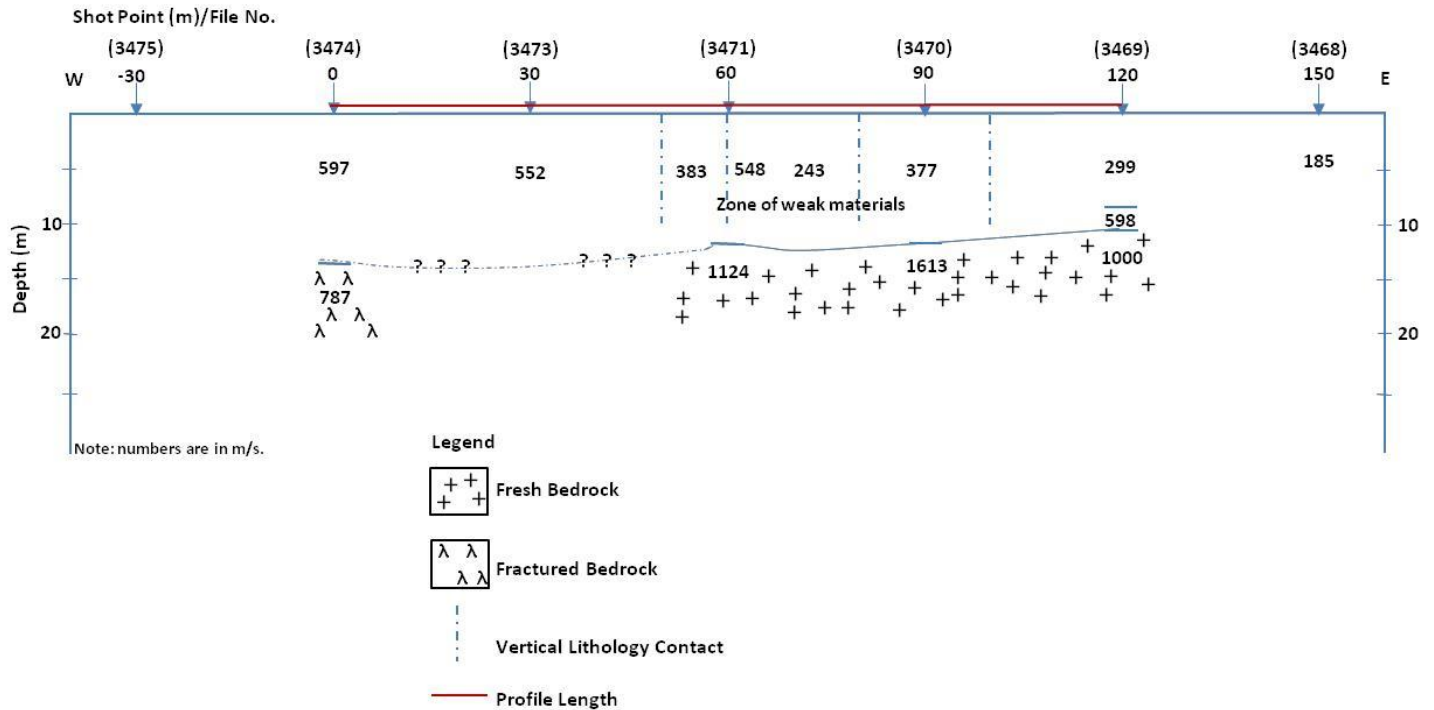
Figure 10. Seismic refraction (geo-velocity) section of profile 2.

Station 50 and 100 m presumably indicative of weak materials. Existence of fractured basement (defined by 787 m/s) is suspected beneath the western limit of the profile. Geo-velocity section generated for profile 3 which is proximal and parallel to the Gurara River on the western flank is presented in Figure 11. Overburden

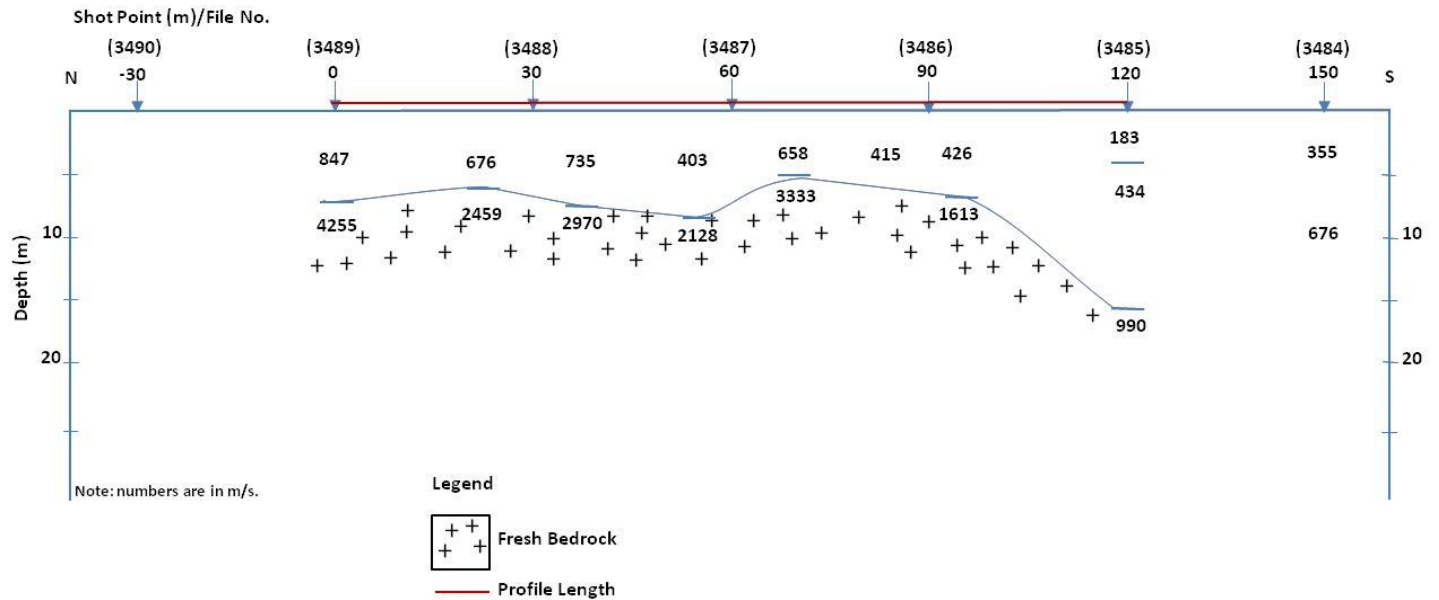
Figure 12. Seismic refraction (geo-velocity) section of profile 4.

bedrock is characterized by very high velocity values varying between 2344 and 5000 m/s. Geo-velocity section generated for profile 4 which is proximal and parallel to the Gurara River on the eastern flank is shown in Figure 12. Overburden materials beneath profile 4 are relatively thin on the northern flank but thicker on the southern limit. The profile is underlain by low velocity materials with values varying between 183 and 847 m/s

with thickness values ranging from 4.04 to 15.61 m. The bedrock is characterized by moderately high velocity values varying between 990 and 4255 m/s.

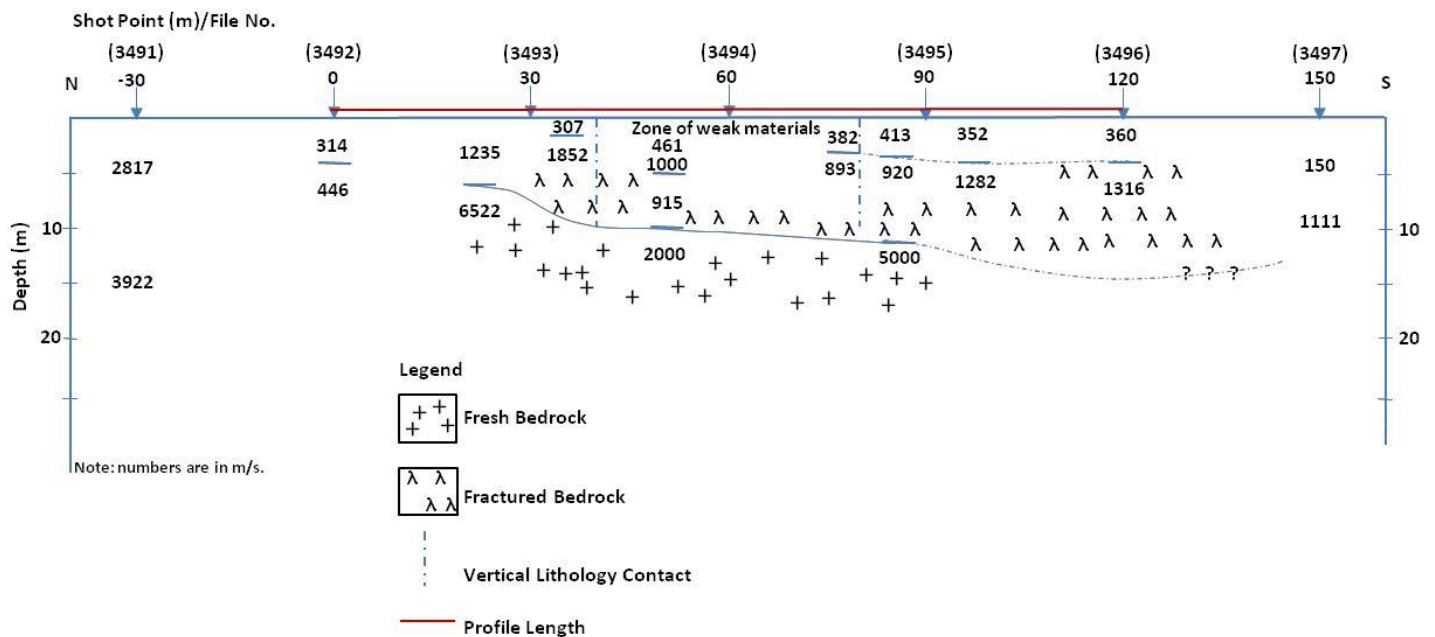
Figure 13. Seismic refraction (geo-velocity) section of profile 5.

Geo-velocity section generated for profile 5 which is located on the extreme eastern flank of the dam axis is presented in Figure 13. Overburden materials (with velocity values of 190 to 1235 m/s) beneath profile 5 are generally thin (1.87 to 5.6 m). The overburden is underlain

by moderately high velocity column with values varying between 446 and 1852 m/s and thickness averaging 5 m that is presumably diagnostic of fractured bedrock. The fresh bedrock is characterized by very high velocity values varying between 2000 and 6522 m/s. The Gurara Dam Phase II project site (dam axis) is underlain by overburden materials that increase westwards. The North-South profiles (1, 3, 4 and 5) are underlain by bedrock of irregular relief. However, the bedrock morphology presents fairly flat relief along the dam axis around profile 2. The bedrock is displaced downwards on the southern flanks of profiles 1 and 4. The seismic refraction sections showed that the river channel area is underlain by basement rocks of relatively higher velocity values as observed in profiles 3 and 4. This suggests the possibility of changes in lithology especially when compared with bedrock velocity values obtained in profiles 1, 2 and 5 that are at some distance from the river channel.
